# Do Green Buildings Perform as Designed: A Case Study of the First LEED<sub>NC</sub> Gold Certified Building at RIT?

Jeffery Rogers<sup>1</sup> and Sultan Alraddadi<sup>2</sup>

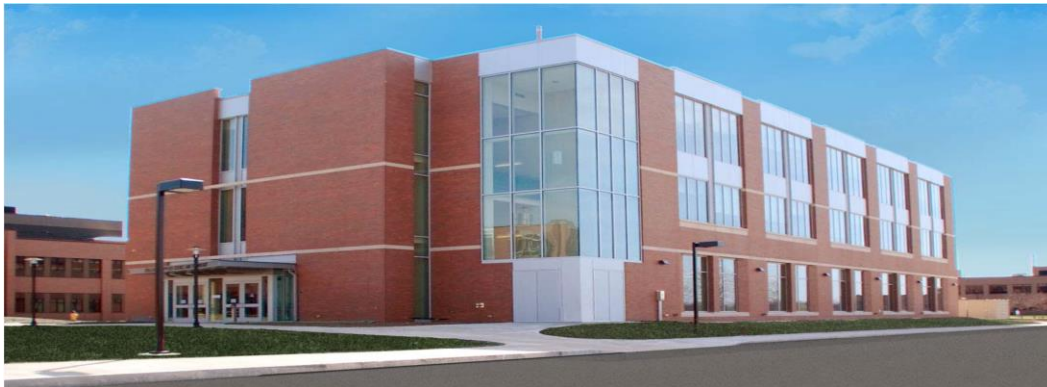
**Figure 1. Pictorial of the CAST building on the RIT campus**

Figure 1 shows the basic layout and orientation of the CAST building on the RIT campus. The document preparation fees for LEED certification was approximately \$59,500 (RIT, FMS, 2008). The capital costs for the design and construction of the associated green feature technologies and strategies for the CAST building were approximately \$157,500 (RIT, FMS, 2008). Finally, the associated operational saving over a 20-year evaluation period for this green building design was estimated to be approximately \$25,000 per year or total of \$500,000 (RIT,

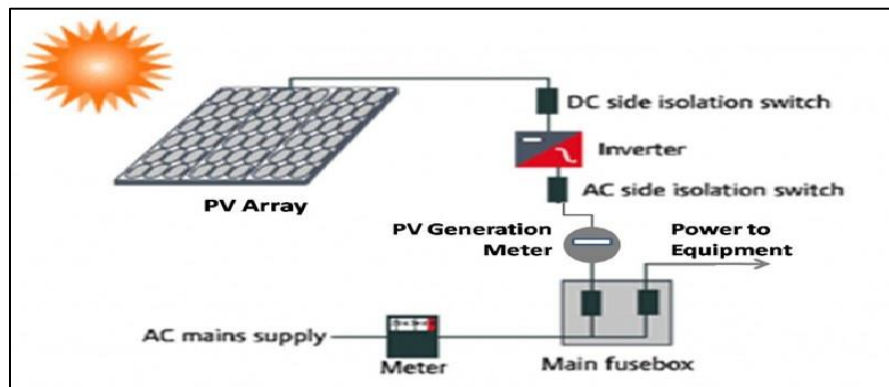
**Figure 3. Schematic Diagram for the Solar Collection System of the CAST Building**

Figure 3 shows the SCS's twelve polycrystalline-silicon solar panels were located on the roof of CAST Building. The design output capacity of each panel is 2.25 KW per hour operated for a total of 27 KW per hour operated. A significant finding was that the existing meter for the SCS had not worked throughout the most of the operational period. Without adequate metering to collect operational data on the energy system within the CAST building it was impossible to accurately determine the level of performance of the green technologies and strategies for the energy system. In addition, the SCS was deactivated for several months due to deficiencies with the inverter.

The most significant green technology is the electrical energy contribution or savings from the Solar Collection System (SCS). The SCS was designed to convert solar energy into electrical energy via an auxiliary AC/DC inverter system, as shown in Figure 3:
